III. Failures, Causes and Countermeasures

6 Rust and Corrosion

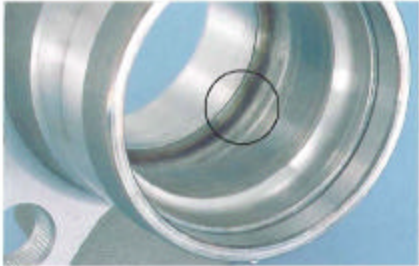
(A-6194) ■ Rust on outer ring raceway surface of Double-Row Cylindrical Roller Bearing Rust on roller pitch.

Phenomena, causes and countermeasures	Examples of failures
Phenomena	<ul style="list-style-type: none"> ■ Rust is a film of oxide, hydroxide, or carbonate produced on a metallic surface by chemical action. ● Corrosion is the phenomena of oxidation or dissolution occurring on the surface and is produced by chemical action (electric chemical action including combination or cell restructuring) with acid or alkali. 	<ul style="list-style-type: none"> ■ Rust on outer ring raceway surface of Double-Row Angular Ball Bearing Rust on raceway surface of one row.

Countermeasures	<ul style="list-style-type: none"> ■ Rust ● Corrosion <ol style="list-style-type: none"> a) Enhancement of sealing capability. b) Periodic inspection of lubricant. c) Provision for adequate rust prevention during storage of bearings. 	<ul style="list-style-type: none"> ■ Rust on outer ring raceway surface of Tapered Roller Bearing

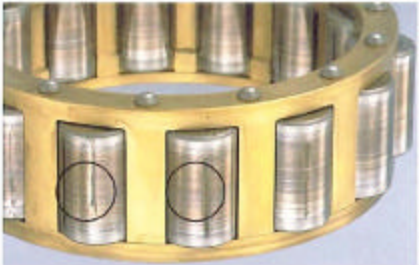
(A-6479) ■ Rust on inner and outer rings and on roller of Tapered Roller Bearing Rust on roller pitch of one row.

(A-6172)
Causes	<ul style="list-style-type: none"> ■ Rust <ol style="list-style-type: none"> 1) When equipment is stopped and its temperature decreases to the dew point, humidity in the housing turns into drops of water. The water drops often contaminate the lubricant. As a result, rust is generated on the bearing surface. 2) When bearings are stored in a humid place for a long time, rust is generated on the raceway surface at intervals equal to the rolling elements spacing. ● Corrosion <ol style="list-style-type: none"> 1) Corrosion occurs when a sulfur or chlorine compound contained in lubricant additives decomposes under high temperature. 2) Corrosion occurs when water gets inside bearings. 	<ul style="list-style-type: none"> ■ Rust on roller rolling surface of Cylindrical Roller Bearing Rust at one position the rollers.
