Trouble Shooting & Failure Analysis

Trouble Shooting Sealing Problems

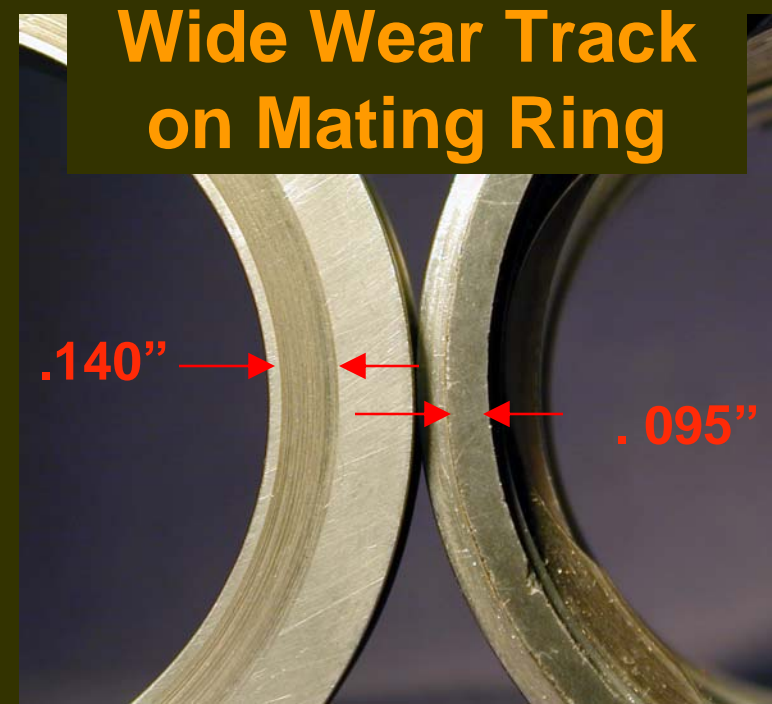
WIDE WEAR TRACK ON MATING RING

POSSIBLE CAUSES

- Worn bearings
- Excessive shaft runnout
- Bent shaft
- Excessive vibration

CORRECTIVE ACTION

- Restore equipment to manufacturer's standards
- Operate equipment under stable conditions

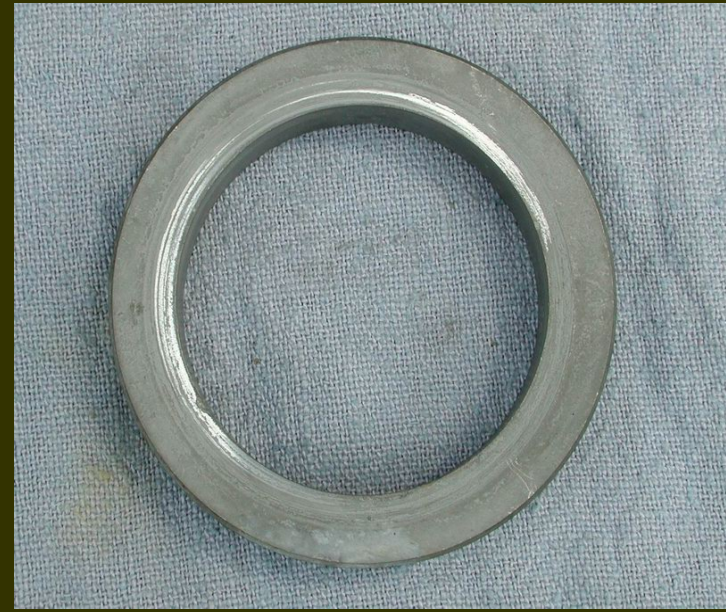
INTERMITTENT SEAL FACE WEAR PATTERN

POSSIBLE CAUSES

- Face not flat
- Gland distortion (uneven tightening)
- Uneven mounting surface

CORRECTIVE ACTION

- Resurface distorted seal ring
- Use proper procedure to tighten gland fasteners

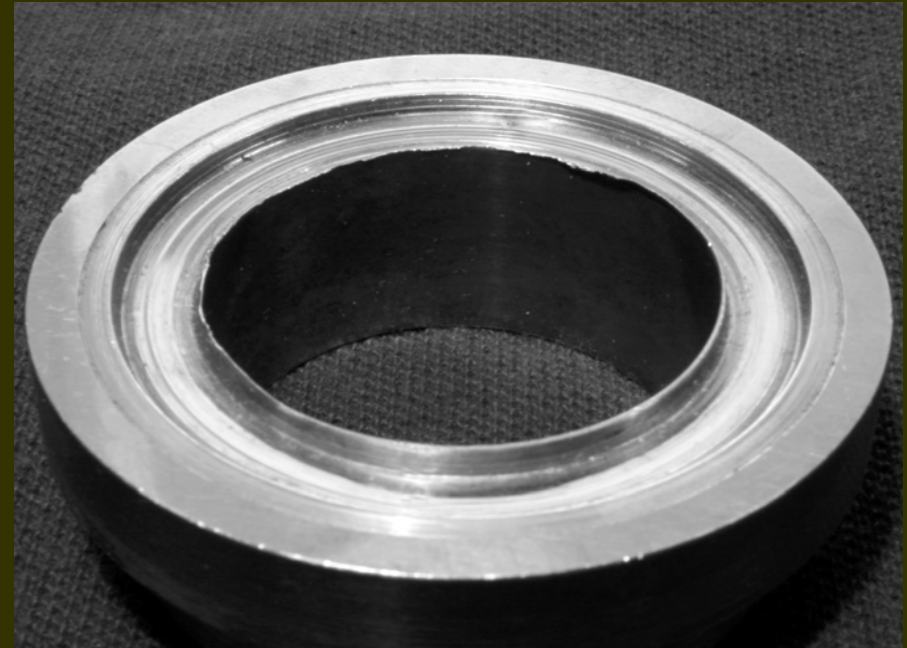
DEEP GROOVE ON SEAL FACE

POSSIBLE CAUSES

- Inadequate lubrication
- Abrasives in process fluid

CORRECTIVE ACTION

- Flush seal with a fluid with good lubricating qualities at an adequate flow rate
- Consider face materials that can withstand abrasive particles
- Prevent crystallization of process fluid

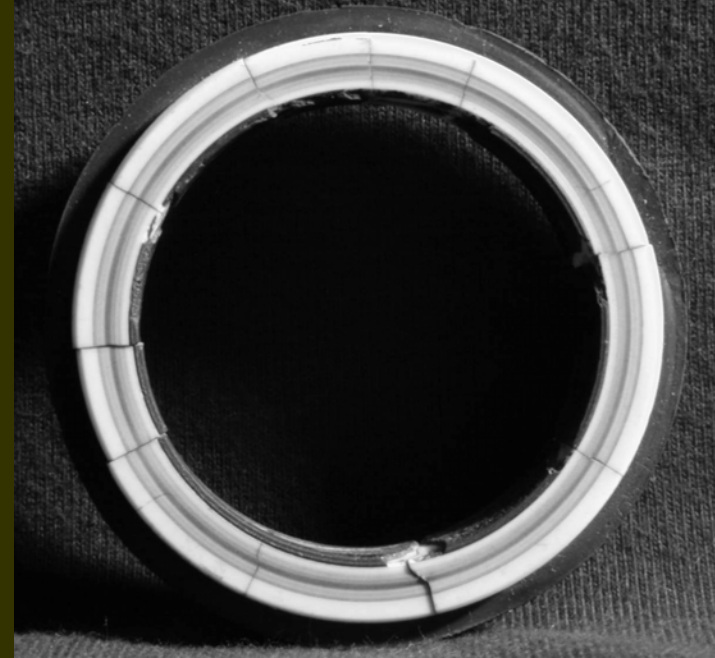
FRACTURED or CRACKED SEAL FACE

POSSIBLE CAUSES

- Thermal shock
- Mechanical shock or impact

CORRECTIVE ACTION

- Avoid uneven or over tightening of fasteners
- Maintain consistent flush to seal
- Determine cause of mechanical shock or impact

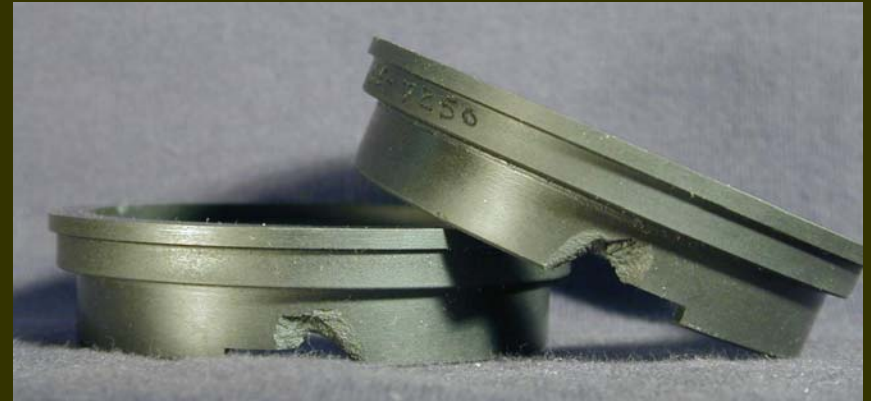
CHIPS, CRACKS IN SEAL RING

POSSIBLE CAUSES

- Mishandling of parts
- Improper installation

CORRECTIVE ACTION

- Follow proper installation procedure
- Avoid point contact or sudden impact of brittle face materials

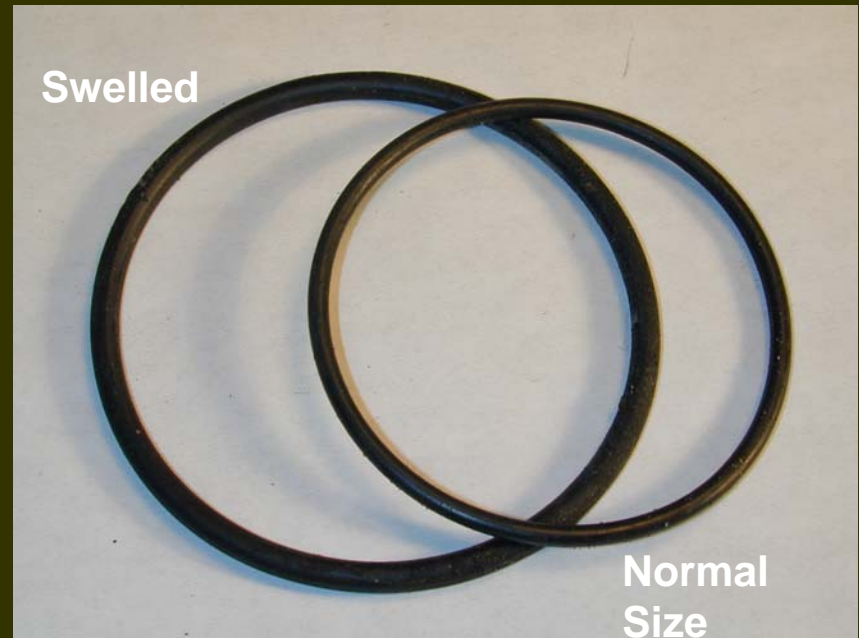
O-RING SWELL

POSSIBLE CAUSES

- Chemical attack

CORRECTIVE ACTION

- Change elastomer to one appropriate for the fluid being pumped

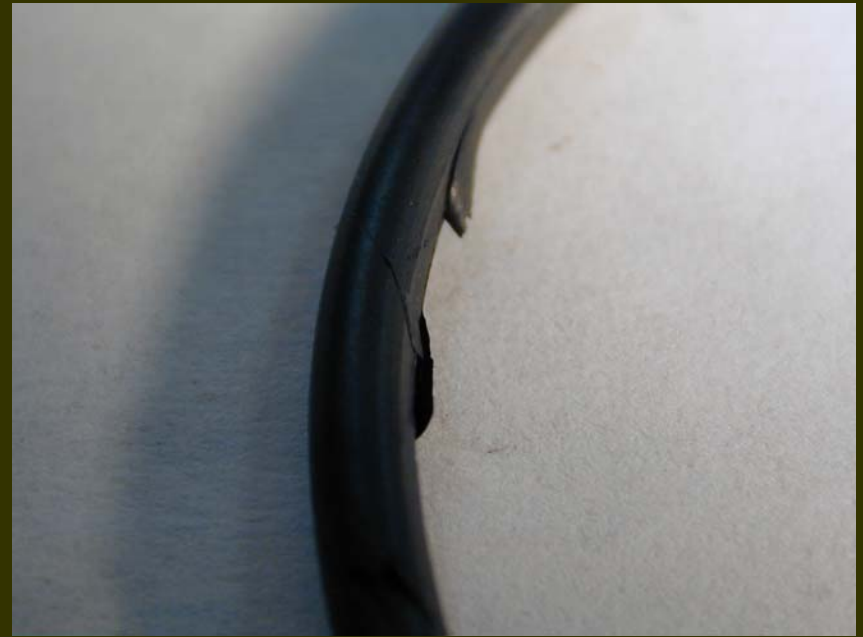
ELASTOMER WITH CUTS & NICKS

POSSIBLE CAUSES

- Improper installation technique
- Sharp steps/surface breaks on mounting surface

CORRECTIVE ACTION

- Use chamfers on shaft and sleeve steps
- Remove sharp edges at keyways, threads, etc.

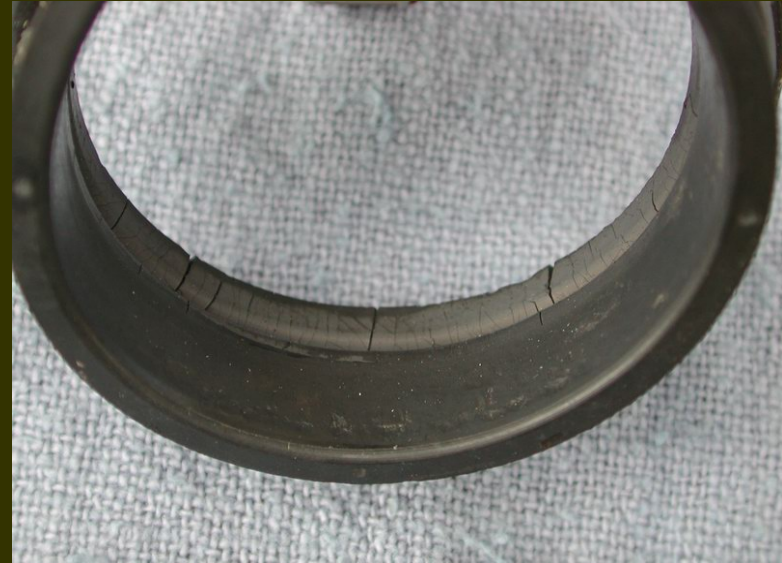
HARD or CRACKED ELASTOMERS

POSSIBLE CAUSES

- Thermal breakdown of compound
- Chemical attack

CORRECTIVE ACTION

- Cool seal chamber
- Select elastomer appropriate for process fluid

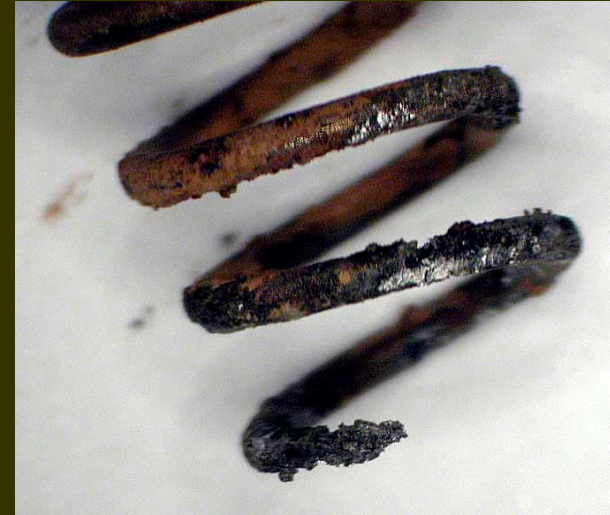
SPRING DISTORTED, CRACKED, BROKEN, CORRODED

POSSIBLE CAUSES

- Excessive shaft speed
- Metal corrosion
- Metal fatigue

CORRECTIVE ACTION

- Select proper metallurgy for sealing application
- Select appropriate type of spring for application

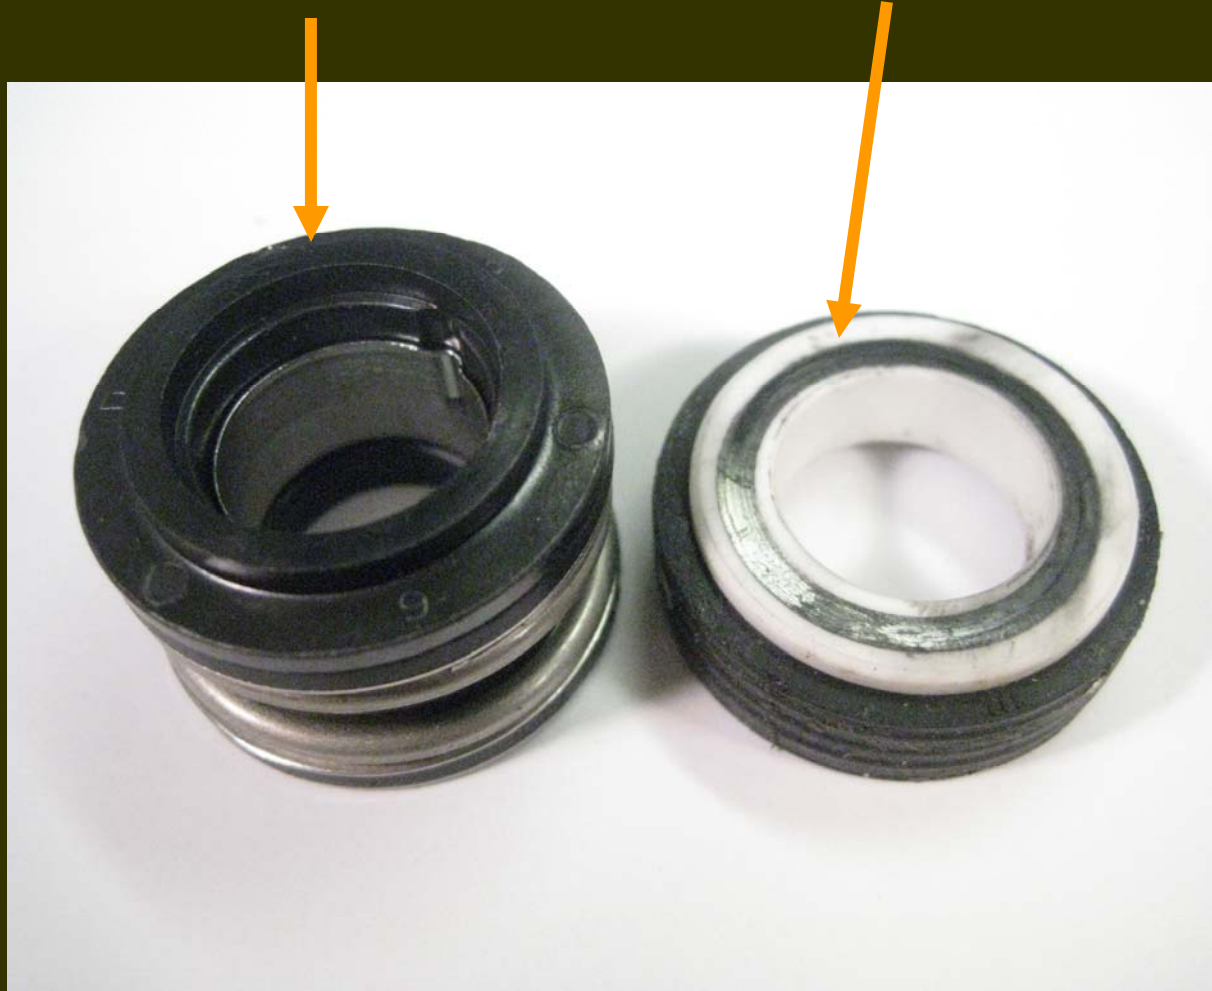
Improper lubricant used to install the seal...
Evidenced by the heavy transfer of carbon
from the Primary Ring to Mating Ring...

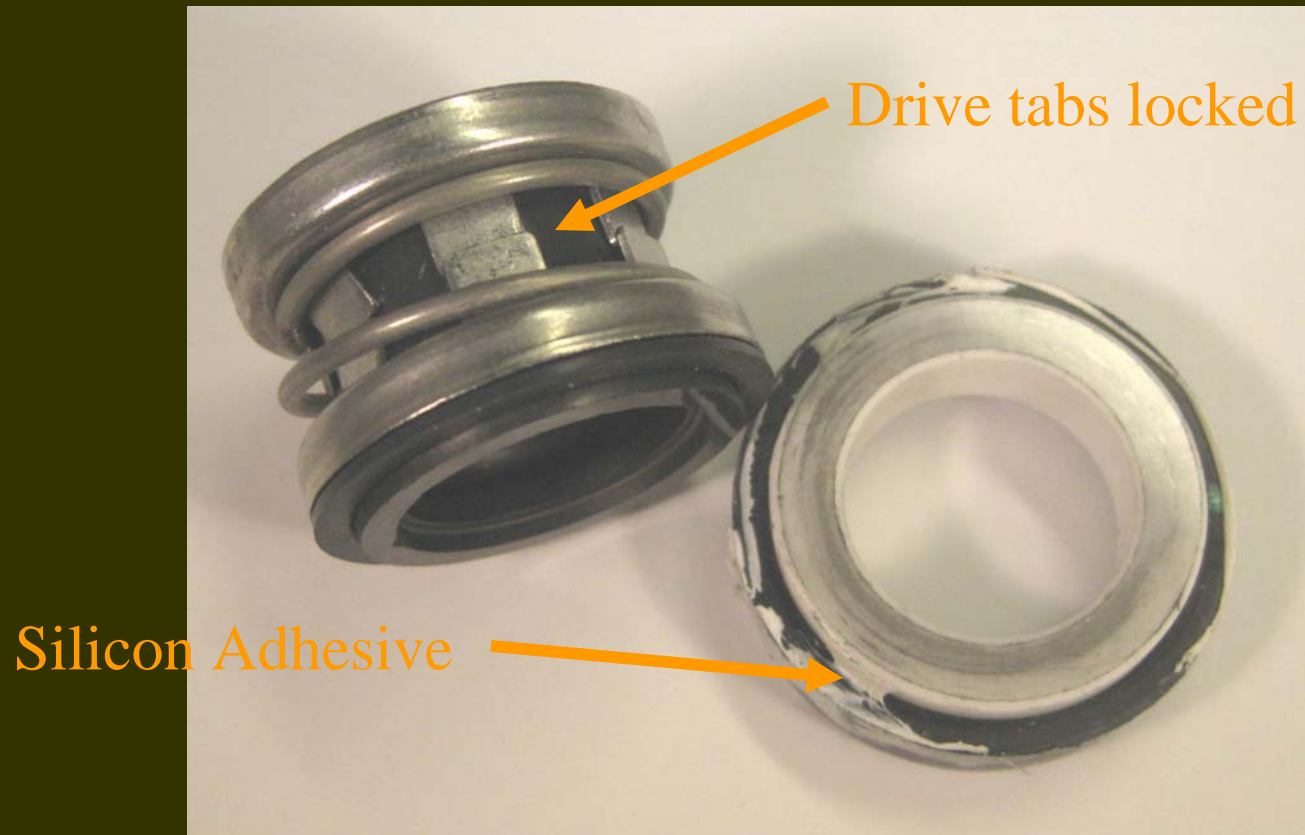
Silicone Adhesive used on cup of Mating Ring caused the seal to stick together and locked the Drive Tabs. Seal was unable to flex and failed.

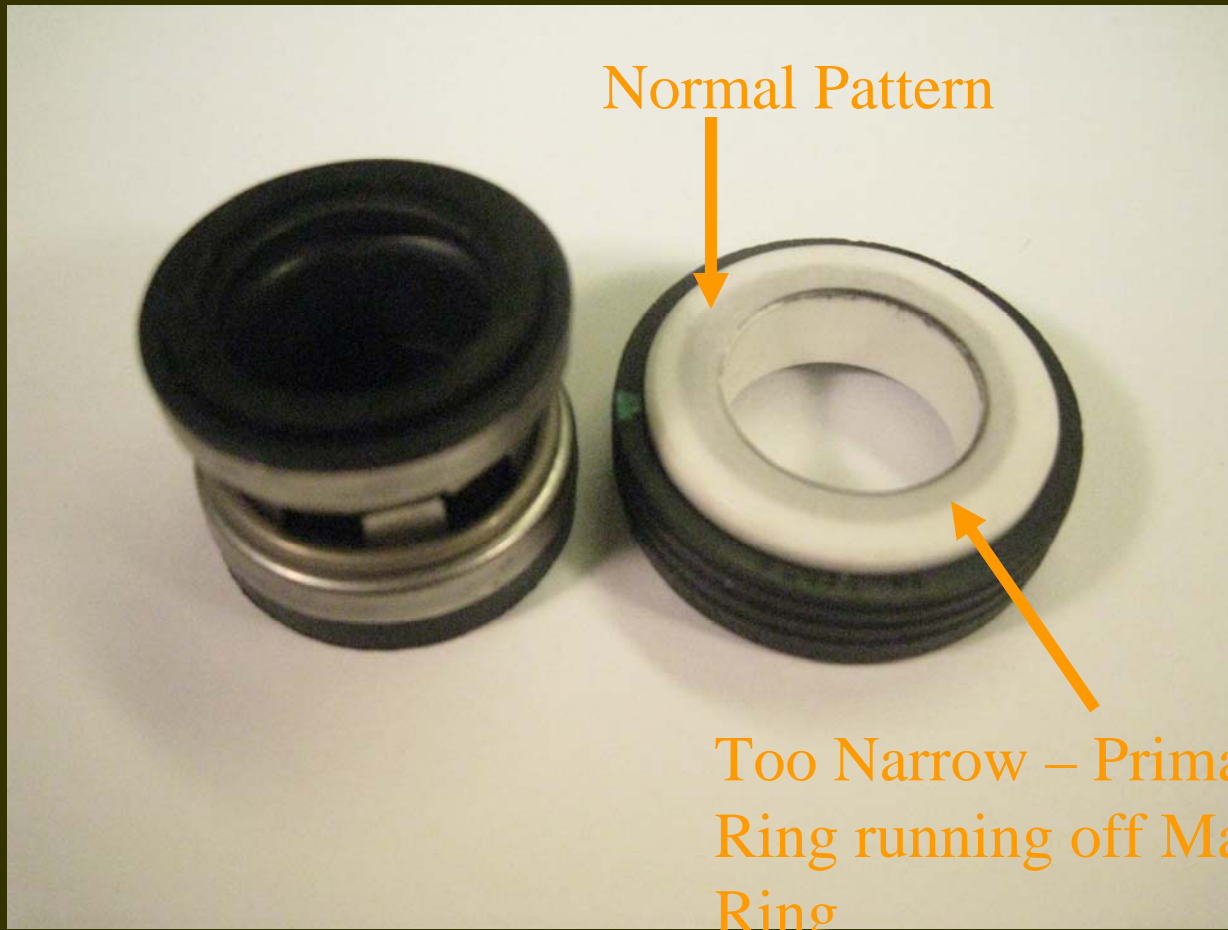
Concentricity and/or bearing/shaft problem.
Note tracking on Mating Ring.

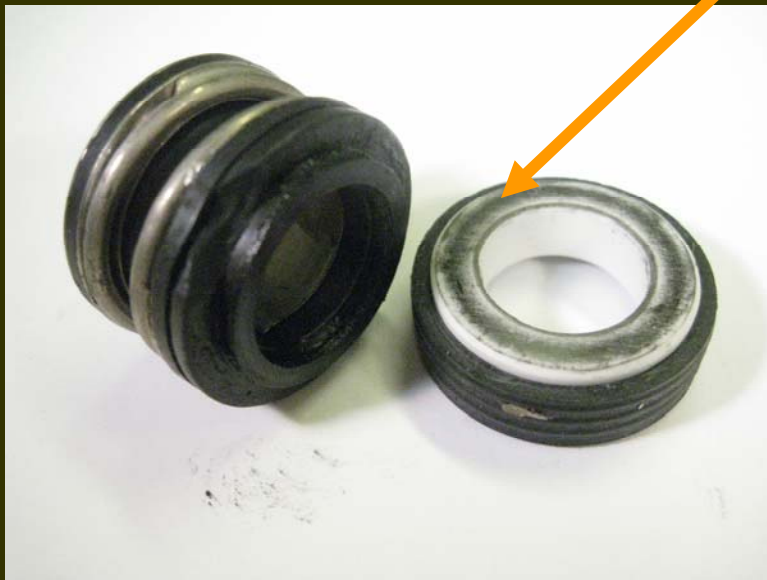
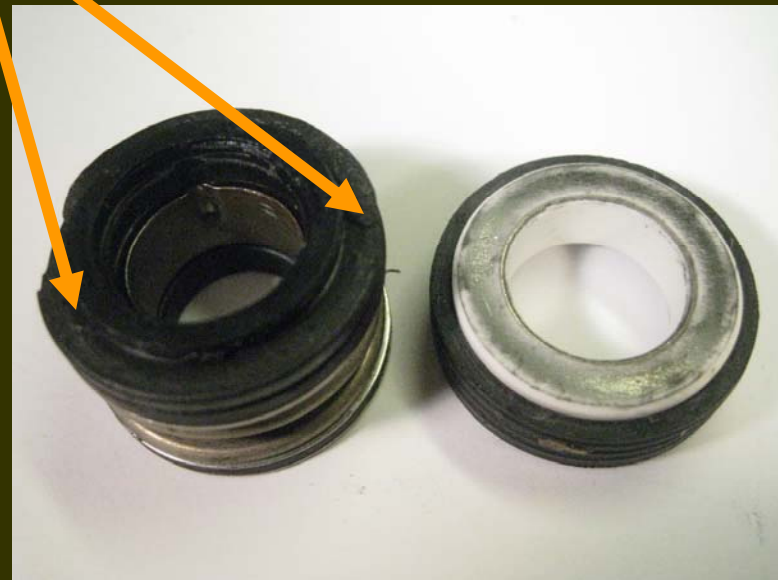
Heavy Grease Used to Install the Seal
